5298 Alta Lake Road
Whistler, BC

Initial Environmental Review: Update

PGL File: 4582-03.02

October 2018

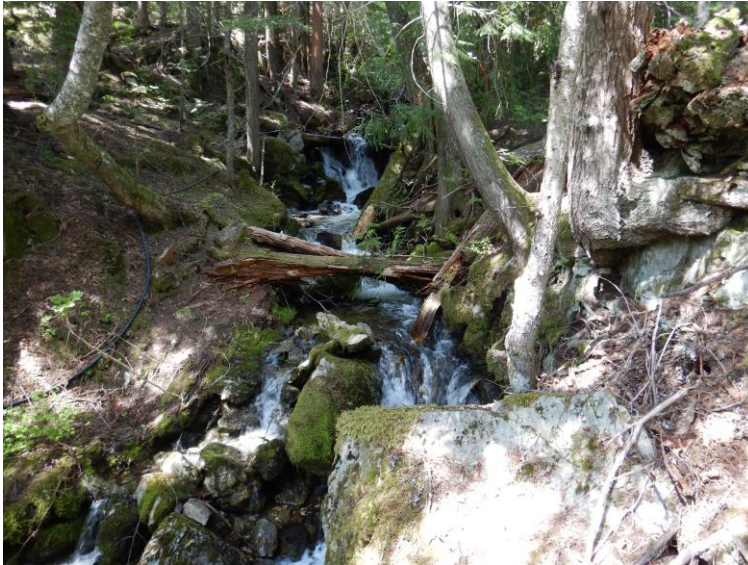
Photograph 1:
**Gebhardt Creek upstream of
access road**

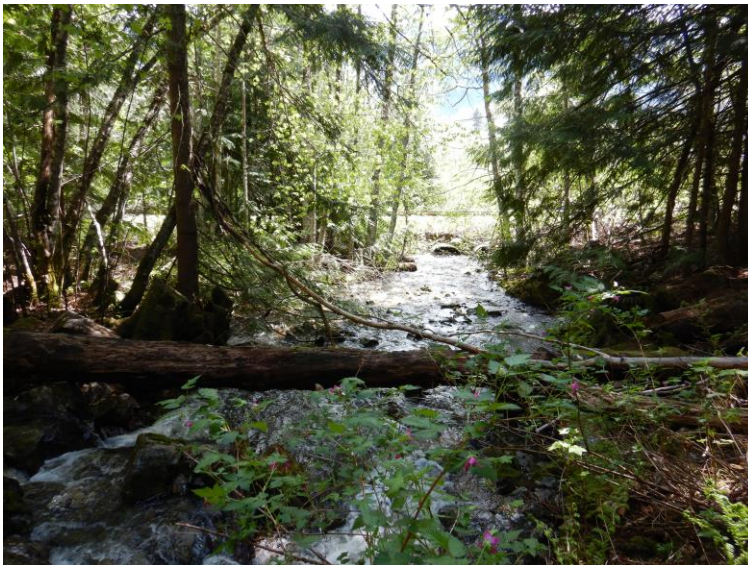
Photograph 2:
**Gebhardt Creek downstream
of access road**

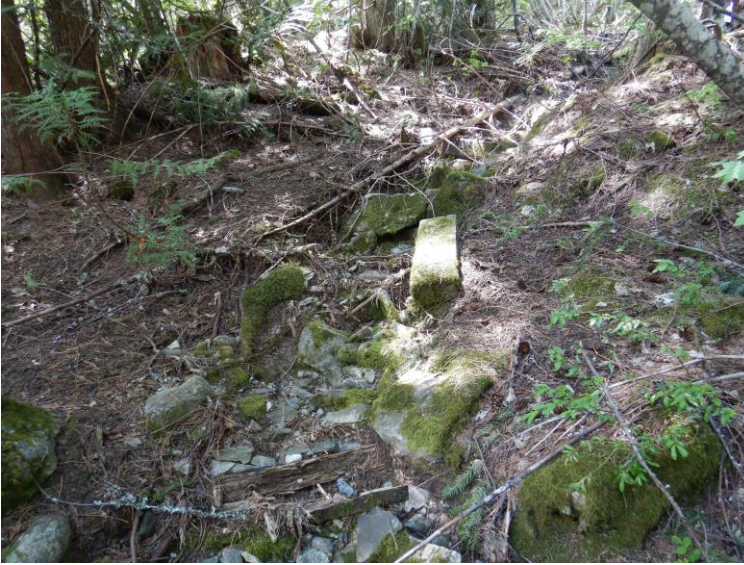
A small channel to the south of Gebhardt Creek was observed to cross the access road through a 0.6m corrugated metal culvert perched above the channel. The channel was mostly dry below the access road (Photograph 3) and was approximately 0.7m wide with an average gradient of 15% close to the access road. The channel joined the Gebhardt Creek floodplain of the lower reach of Gebhardt Creek, just upstream of the CN Rail tracks. In the flatter section of the flood plain, the channel was dry, with gravels exposed due to scour. Closer to the access road, the grade of the channel was steeper and angular boulders and cobbles were observed, with old silt fence visible on the channel margin. Upstream of the access road, the channel had some flow, with other sections dry and water flowing subsurface/infiltrating to ground. A concrete headwall diverted water through to the culvert under the access road. The channel upstream of the access road had a step-pool morphology (Photograph 4), and was 1.4m wide and 15% on average in gradient. It is suspected that this channel is the man-made diversion channel described in the Cascade 2000 report.

Photograph 3:
**Side channel downstream of
access road**

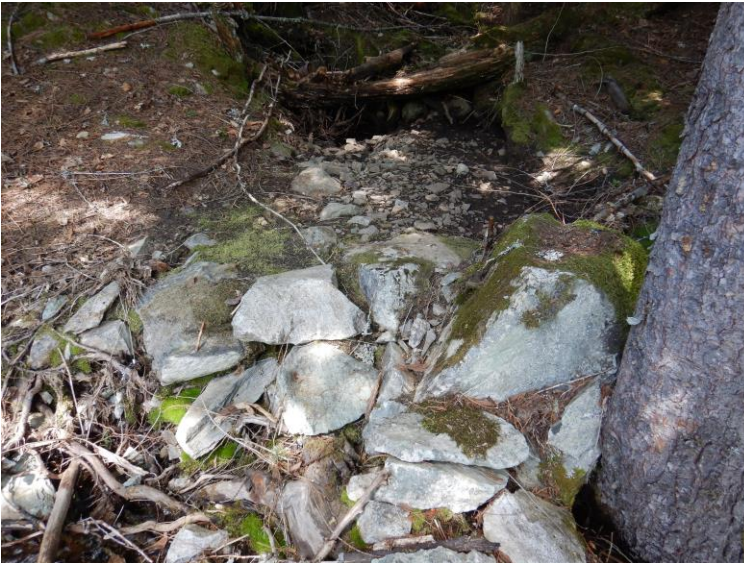
Photograph 4:
**Side channel upstream of
access road**

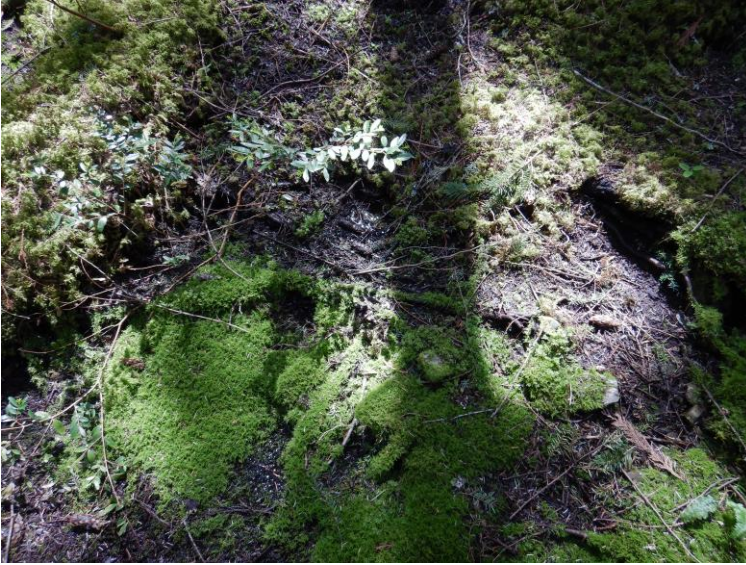
Evidence of several intermittent seepages or extinct drainages were observed at the Site (Photograph 5). The seepages were generally dry at the time of the site visit, and likely only convey site runoff during storm events and snowmelt.

Photograph 5:
Mossy seep in Polygon 1

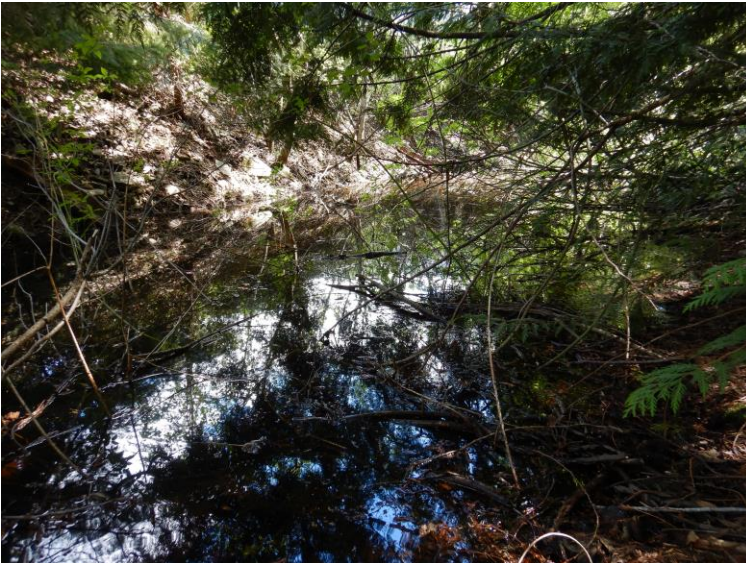
A shallow pool was observed in the southeast corner of the Site (Photograph 6). This pool is consistent with descriptions of a pool in the same area in the Cascade 2000 report. The pool contained aquatic invertebrates, and juvenile trout approximately 75mm in fork length was noted swimming in the pool. The trout was assumed to be a rainbow trout, but species could not be confirmed. The observation of the fish was surprising given the appearance of isolation from Nita Lake and other watercourses. However, on observation of the Nita Lake side of the CN Rail tracks that separate the pool from the lake, a possible connection beneath the CN Rail tracks was noted as probable.

The pool in the southeast corner of the Site was observed to have at least one juvenile trout (species not confirmed, but likely rainbow trout), and aquatic invertebrates. It is unknown how the pool connects to the Lake; however, it is suspected that a subsurface connection, either by culvert or erosion, connects the pool to Nita Lake.

Photograph 6:
**Pool in southeast corner of
Site, Polygon 4**

The presence of fish in the pool in Polygon 4 is a constraint on the development of the Valley Trail, and, potentially, on the recontoured slopes under the townhouse units at the southeast end of the Site. A RAR assessment to establish a SPEA is recommended.

- Veteran trees and danger trees should be surveyed by a professional arborist to determine individuals for preservation and potential hazard trees and map locations;
- Fish sampling in the pool in Polygon 4 should be conducted to determine the species presence and population of the fish in the pool, and an assessment of the water connection to Nita Lake is recommended to determine sensitivities and constraints to development near the Polygon 4; and
- Seeps, rocky outcrops, and the wetland should be surveyed for rare and endangered plants for the purpose of determining rare plant presence and suitability for salvage and transplant.

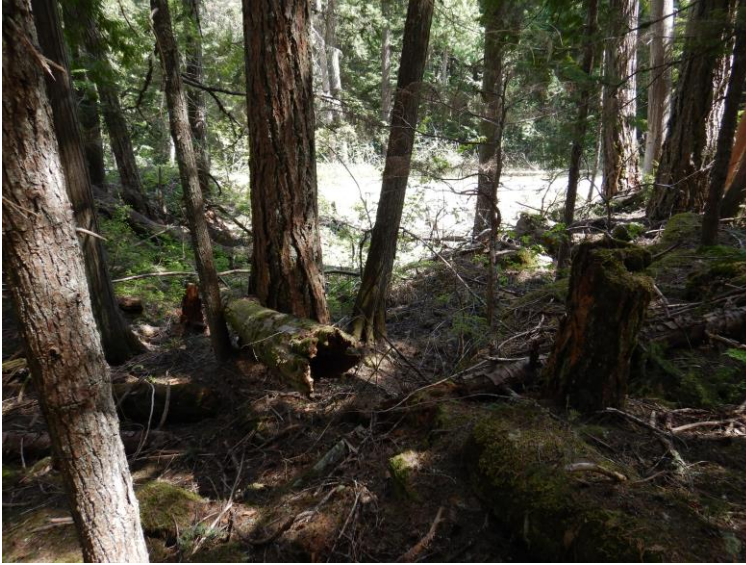
Photograph 7:
Polygon 1 typical habitat

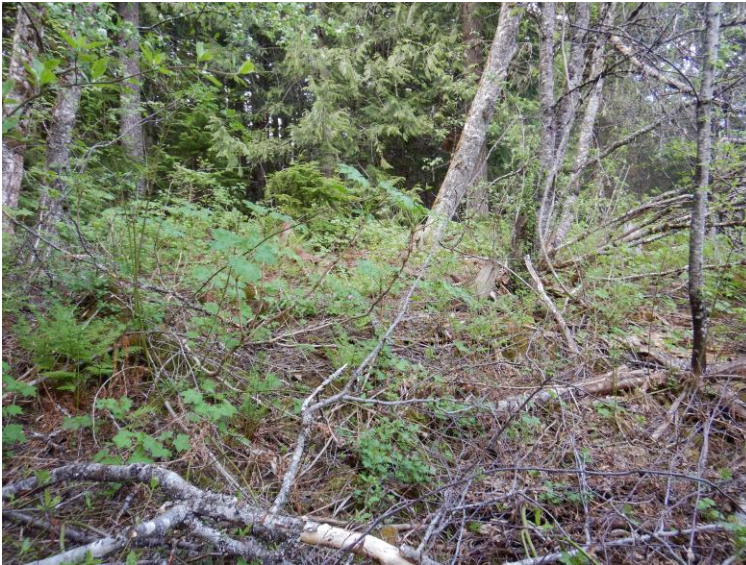
Photograph 8:
Polygon 4 adjacent the pool

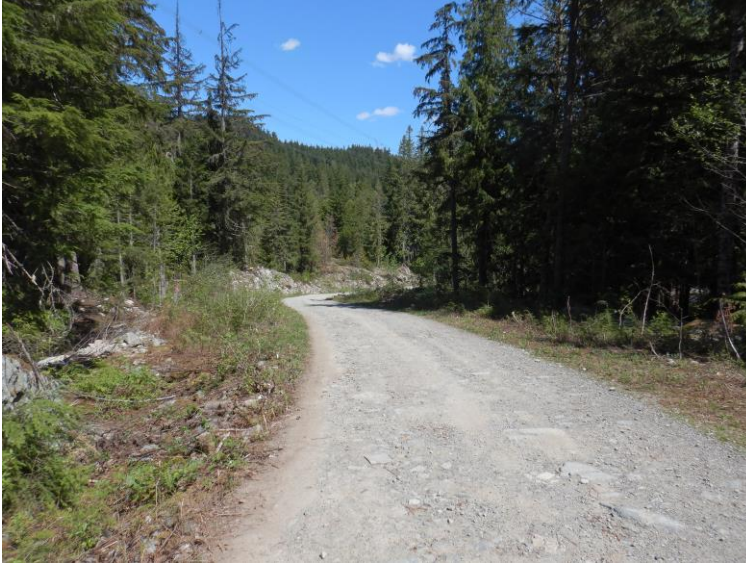
Photograph 9:

This polygon includes the gravel access road (Photograph 9) off Nita Lake Drive and adjacent utility corridor, gravel parking areas, buildings and lawn. Evidence of clearing and grubbing was observed along the gravel access road, likely completed during the construction of the road and utility corridor.

**Gravel access road through
the Site**

- Invasive plant species were observed along the access road and adjacent areas, and the CN Rail track. Invasive species should be managed accordingly during pre-development, including the preparation of an Invasive Plant Management Plan;
- A geotechnical survey of the proposed development areas should be conducted by a qualified professional;
- A Preliminary Field Reconnaissance should be completed to assess the potential for archaeological resources protected under the *Heritage Conservation Act*;
- A Riparian Areas Regulation assessment of watercourses on the Site should be completed by a QEP to determine Streamside Protection and Enhancement Area setbacks and the applicability of the diverted side channel and pool;
- A raptor nest survey should be conducted to determine the presence of any raptor nests on Site prior to development; and

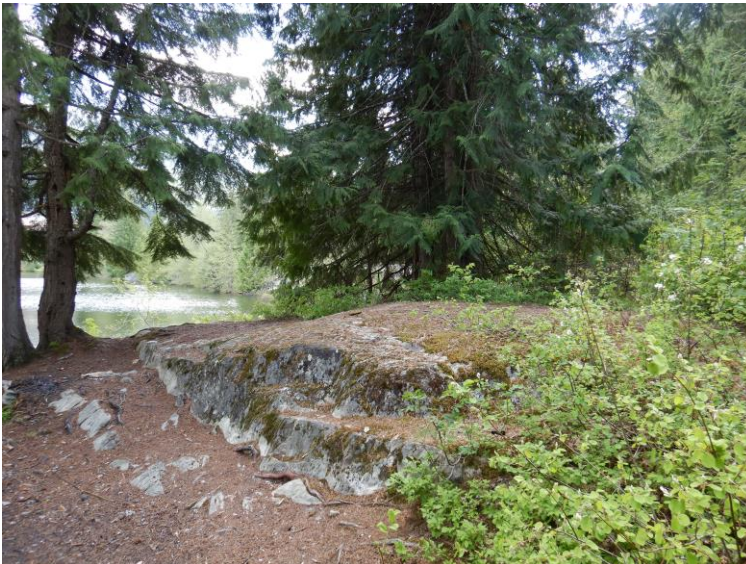
Photograph 10:

**Polygon 7 rock outcrop and
park area**

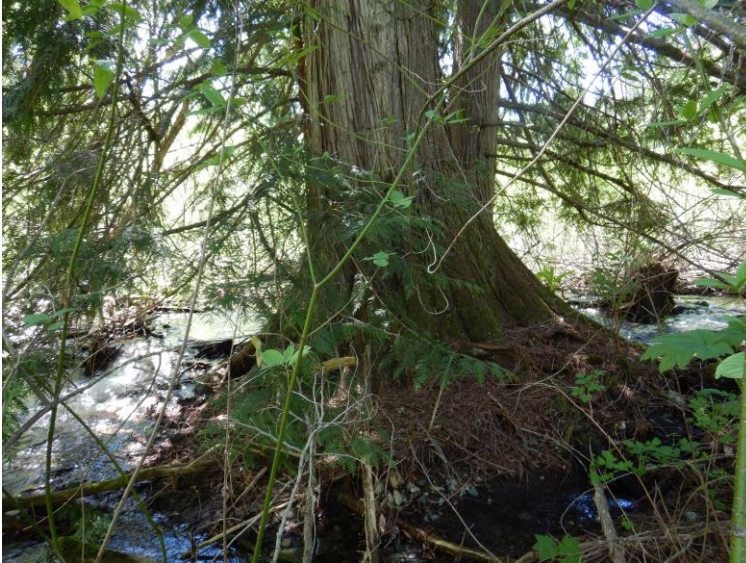
Photograph 11:

**Polygon 8, Gebhardt Creek
braided around a large western
redcedar**

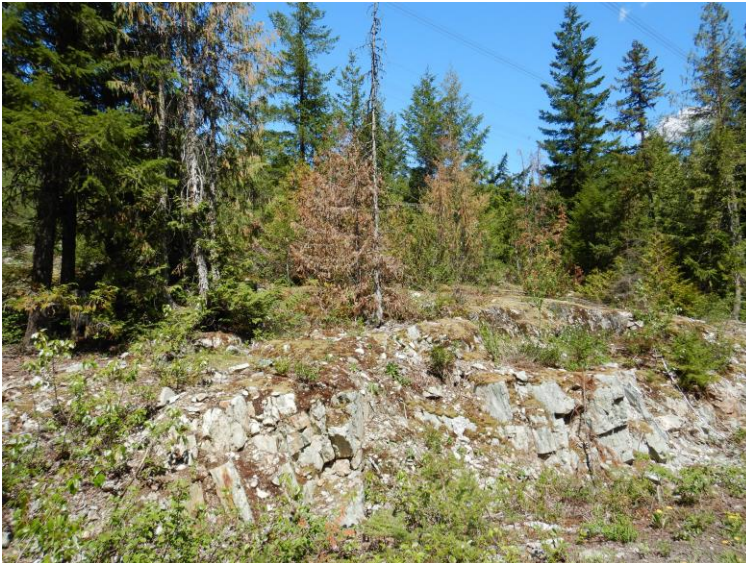
Photograph 12:

An opening in the dense canopy of the adjacent Polygon 1 areas was observed where the Site boundary was in close proximity to the BC Hydro transmission ROW. The area was perched on a rock outcrop with thin soils (Photograph 12). Tree cover was sparse with young black cottonwoods and red cedars that were unhealthy or dying. Saskatoon berry and oval leaf blueberry were present as mid-story shrubs, and desiccated mosses covered the rock.

**Polygon 9, rock outcrop
adjacent BC Hydro ROW**

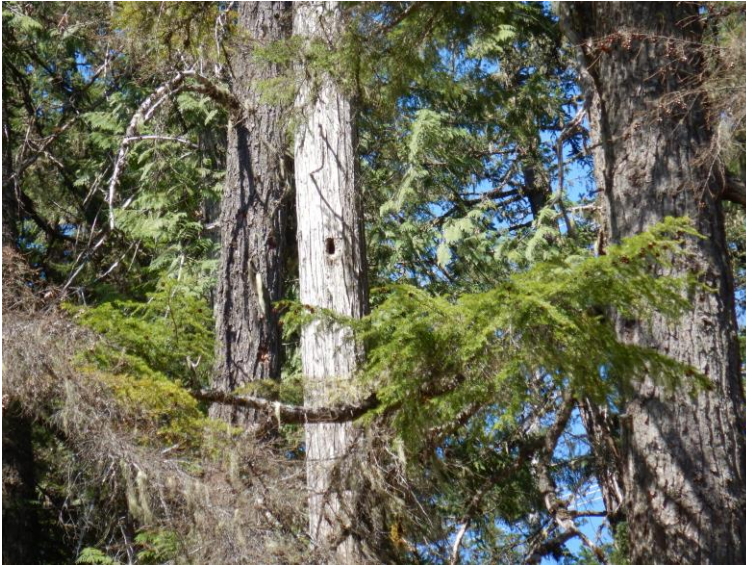
Photograph 13:

Wildlife trees were frequently encountered at the site. Wildlife trees observed included feeding trees for woodpeckers, and cavities for nesting (Photograph 13). Large, rectangular pileated woodpecker feeding cavities were of note (Photograph 14). Nest cavities observed ranged in size and age; however, most cavities were in the size range of those created by northern flicker. The nest cavities were often between 5 and 10m from the ground, and of the appropriate size to be used by secondary cavity nesters such as Northern saw-whet owl (*Aegolius acadicus*), Northern pygmy owl (*Glaucidium gnoma*), Western screech-owl (*Megascops kennicottii*), Northern flying squirrel (*Glaucomys sabrinus*), and Douglas squirrel, among other bird and mammal species. Cavities at the base of trees were also observed, with space for medium-sized mammals, such as fisher (*Martes pennanti*) and American mink (*Neovison vison*). Large veteran trees may also provide valuable sites for roosting raptors, and potentially nesting. No raptor nests were observed on site.

**Nest cavity observed in
Polygon 2**

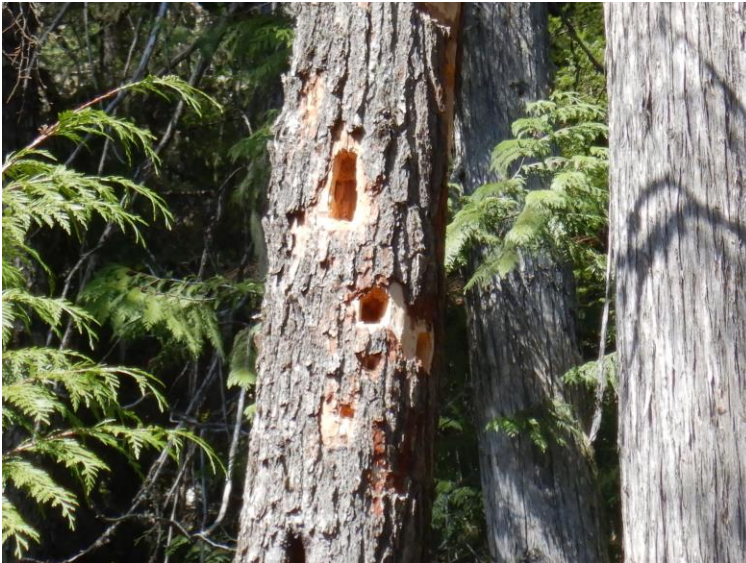
Photograph 14:

The wildlife trees on site were a mixture of standing dead trees (snags) or stumps, and live coniferous trees. Feeding holes were observed in snags and stumps, as expected, while cavities were often in living trees.

**Woodpecker feeding holes in
Polygon 2**
